## Failure Analysis Of Water Pump Shaft

Didik Ariwibowo\*, Sulthonul Putra, Seno Darmanto, Juli Mrihardjono, Wiji Mangestiyono

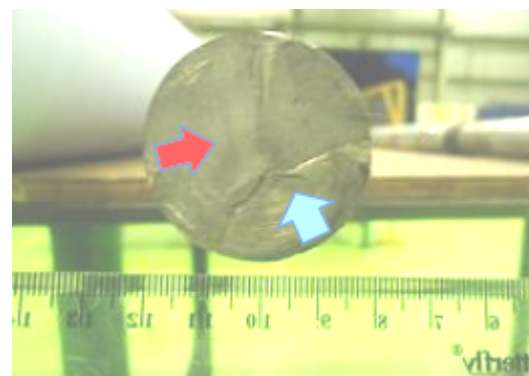
Visual inspection was carried out to analyze the modes of failure. One of the picture can be seen at Fig.2. This leading to hypotheses that shaft failed in torsion loading condition. The figure shows that there is a crack initiation. This mode of failure was consider that shaft sustained a rotational load that cause the tensile stress over its ultimate strength. This initial crack was mis-inspection. From historical maintenance data, the shaft was not checked for it.

Figure 2 also shows that the fracture plane was perpendicular to the longitudinal plane of the shaft. It was indicated that crack propagation occurred under induced flexural fatigue loading.

Figure 2. Modes of failure: a. initial crack portion (lower arrow), and b. failure portion (upper arrow)

There are three portion area of the failure, portion that large plastic deformation occurs (large portion), portion of brittle fracture, and portion of rotational bending fatigue characteristic. A large portion of the failure surface was flattened and smeared off. This surface condition was considered due to a repeated grinding against the fracture surface with mating part while the motor runs after complete fracture. The fatigue occurs because of pump operation over 40000 hours without preventive maintenance.

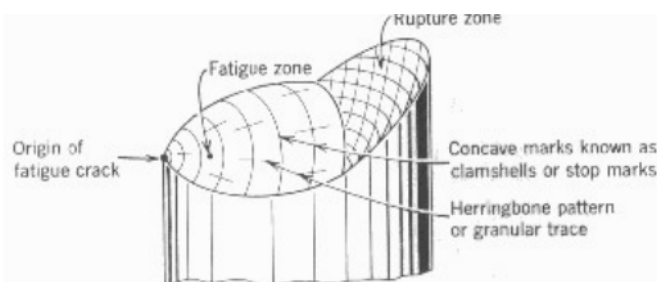
Figure 2 shows that there also was a fatigue zone. The fatigue zone can be described as follows: a smooth rubbed, and velvety appearance, the presence of waves known as "clam-shells" or "oyster-shells", "stop marks" and "beach marks," and the herringbone pattern or granular trace which shows the origin of the crack, as seen at Fig3 [6]. In general, stop marks indicate the variations in the rate of crack propagation due to variations in stress amplitude in a cyclic application varying with time.

Figure 3. Failure zone

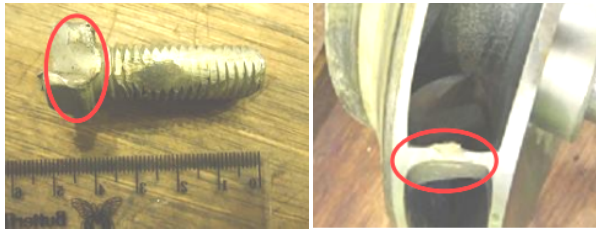
The cause of the over tensile strength was of the foreign material, those are sand and bolt in pump chamber. The bolt that found in the chamber and damage of impeller can be seen at Fig.4. The rotation of shaft was stuck by the bolt, cause tensile stress increased in the shaft over its tensile strength. The initial crack extents until shaft

broken. Besides the stuck, imbalance that cause of bolt exerted in impeller could also be contributor of shaft failure. It can also be seen that their direction of initial crack and failure was different. This is caused by maintenance activity that change the vertical position of the shaft. This failure phenomena is similar to that in pump shaft failure studied by some researcher [2, 3, 4, 5].

Figure 4. Bolt in pump chamber and damage of impeller

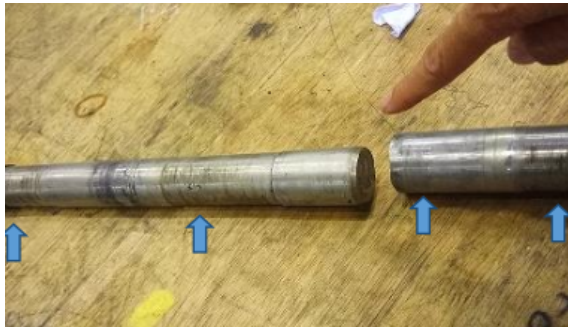
Another cause of failure was worn out of shaft at bearing location, that can be seen at Fig. 4. This wear cause the shaft cross section area reduced and lack to withstand tensile stress. The stress is a high stress level of induce fluctuating stresses that exerts from a start and stop cycle mode of operation. The shaft experiences cyclic flexural load and torsional load during pumping operation. At this location, an excessive plastic deformation could be induced and severe localized stress occurs. This would lead to fatigue crack. The mass of shaft is an factor that induce cyclic flexural stress. This stress is distributed uniformly along the length of the shaft between the bearing supports. At the bearing support, reduced cross section area induces a local stress gradient then this stress could be the contributor to failure of the shaft. The fillet corner was too sharp to withstand the stress concentration for longer duration.

Figure 4. Shaft cross section area reduction caused by wearing out of bearing bushing
