## Failure Analysis Of Water Pump Shaft

Didik Ariwibowo\*, Sulthonul Putra, Seno Darmanto, Juli Mrihardjono, Wiji Mangestiyono

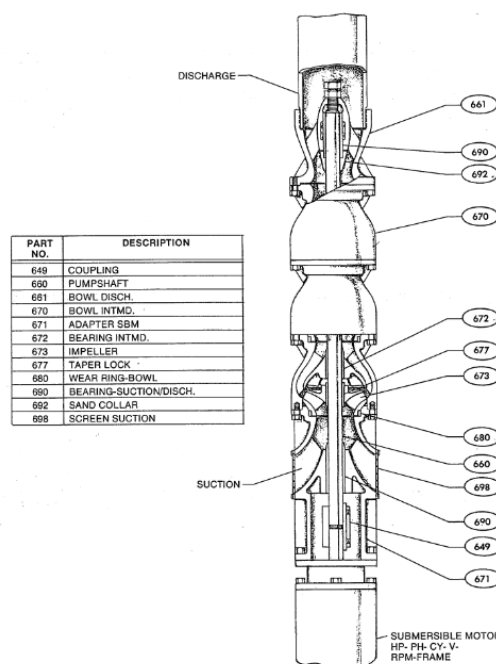
Figure 1. Vertical Centrifugal Pump

On November, the pump failed. An information stated that the pump was stop working. After being brought to the shop and initial inspection, it was found that pump shaft broken to near half of the length of the pump shaft, and some impeller parts were damaged at side of the blade. Further, more foreign particles such as sand and new pebbles and bowl bolts casing inside the pump was found.
